Maple Valley - Legacy Site

Comparative Analysis and Tree Survey

Legacy Site Tree Survey: 11/10/2017 & 11/18/2017

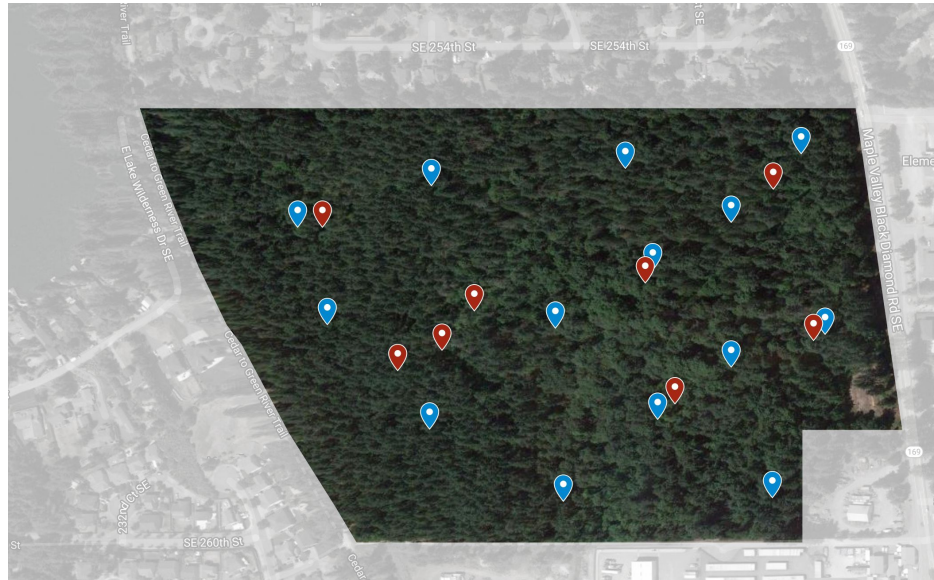
Collaborating with students from the School of Environmental and Forest Sciences, 14, 1/20th acre plots were surveyed throughout the Legacy Site. Using state of the art technology to record tree height, circumference, and location, we were then able to extract useful information applicable to future development research.

Tree Measures:

- Species
- Height
- Circumference
- Location
- Surrounding Features

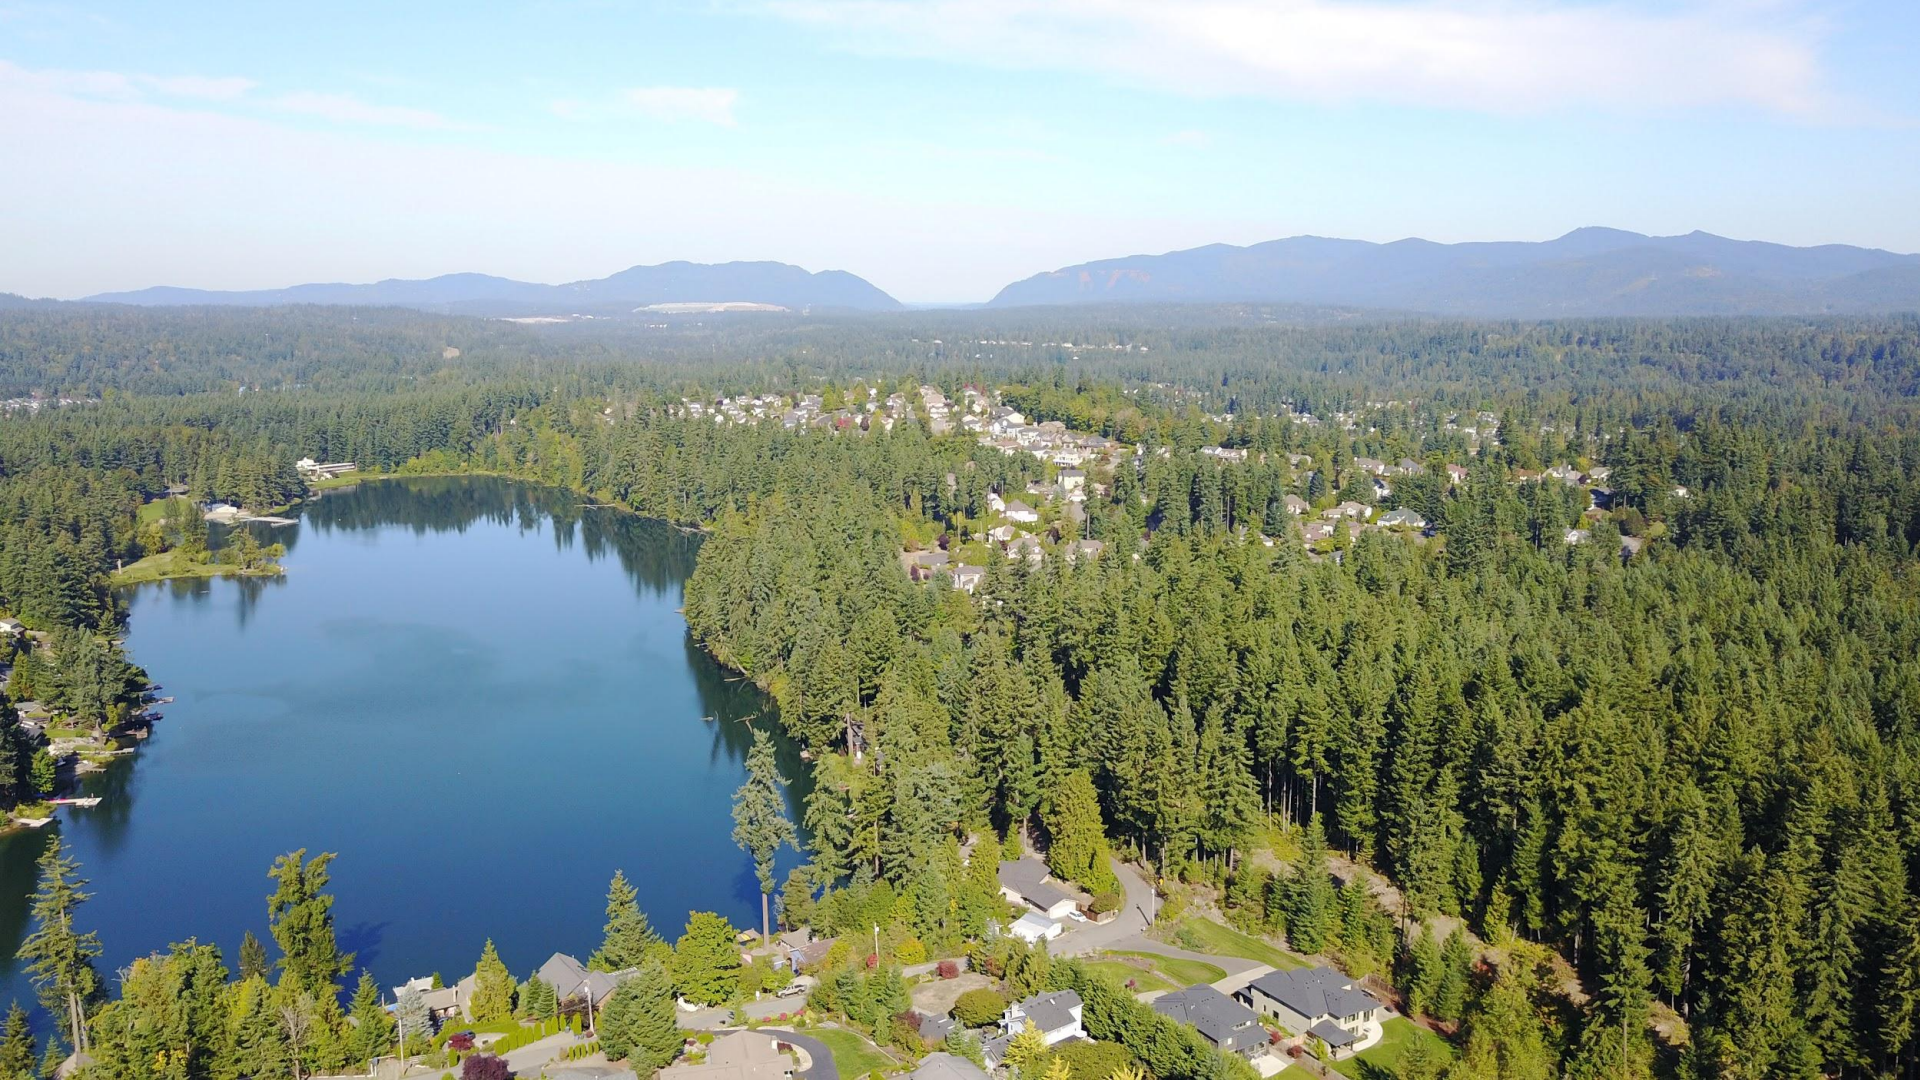
Topographic Map

Walking through the Legacy Site provides a first hand look of this diverse terrain. A network of pathways allow pedestrians to wander up hills, through plateaus, and around local habitats.

Natural Guiding Features

Forested Swales:

Shallow, low-lying and intermittent drainage ways.

Forested Steep Slopes:

Moderate and typically steep slopes (10% or greater)

Local High Point

Local Low Point

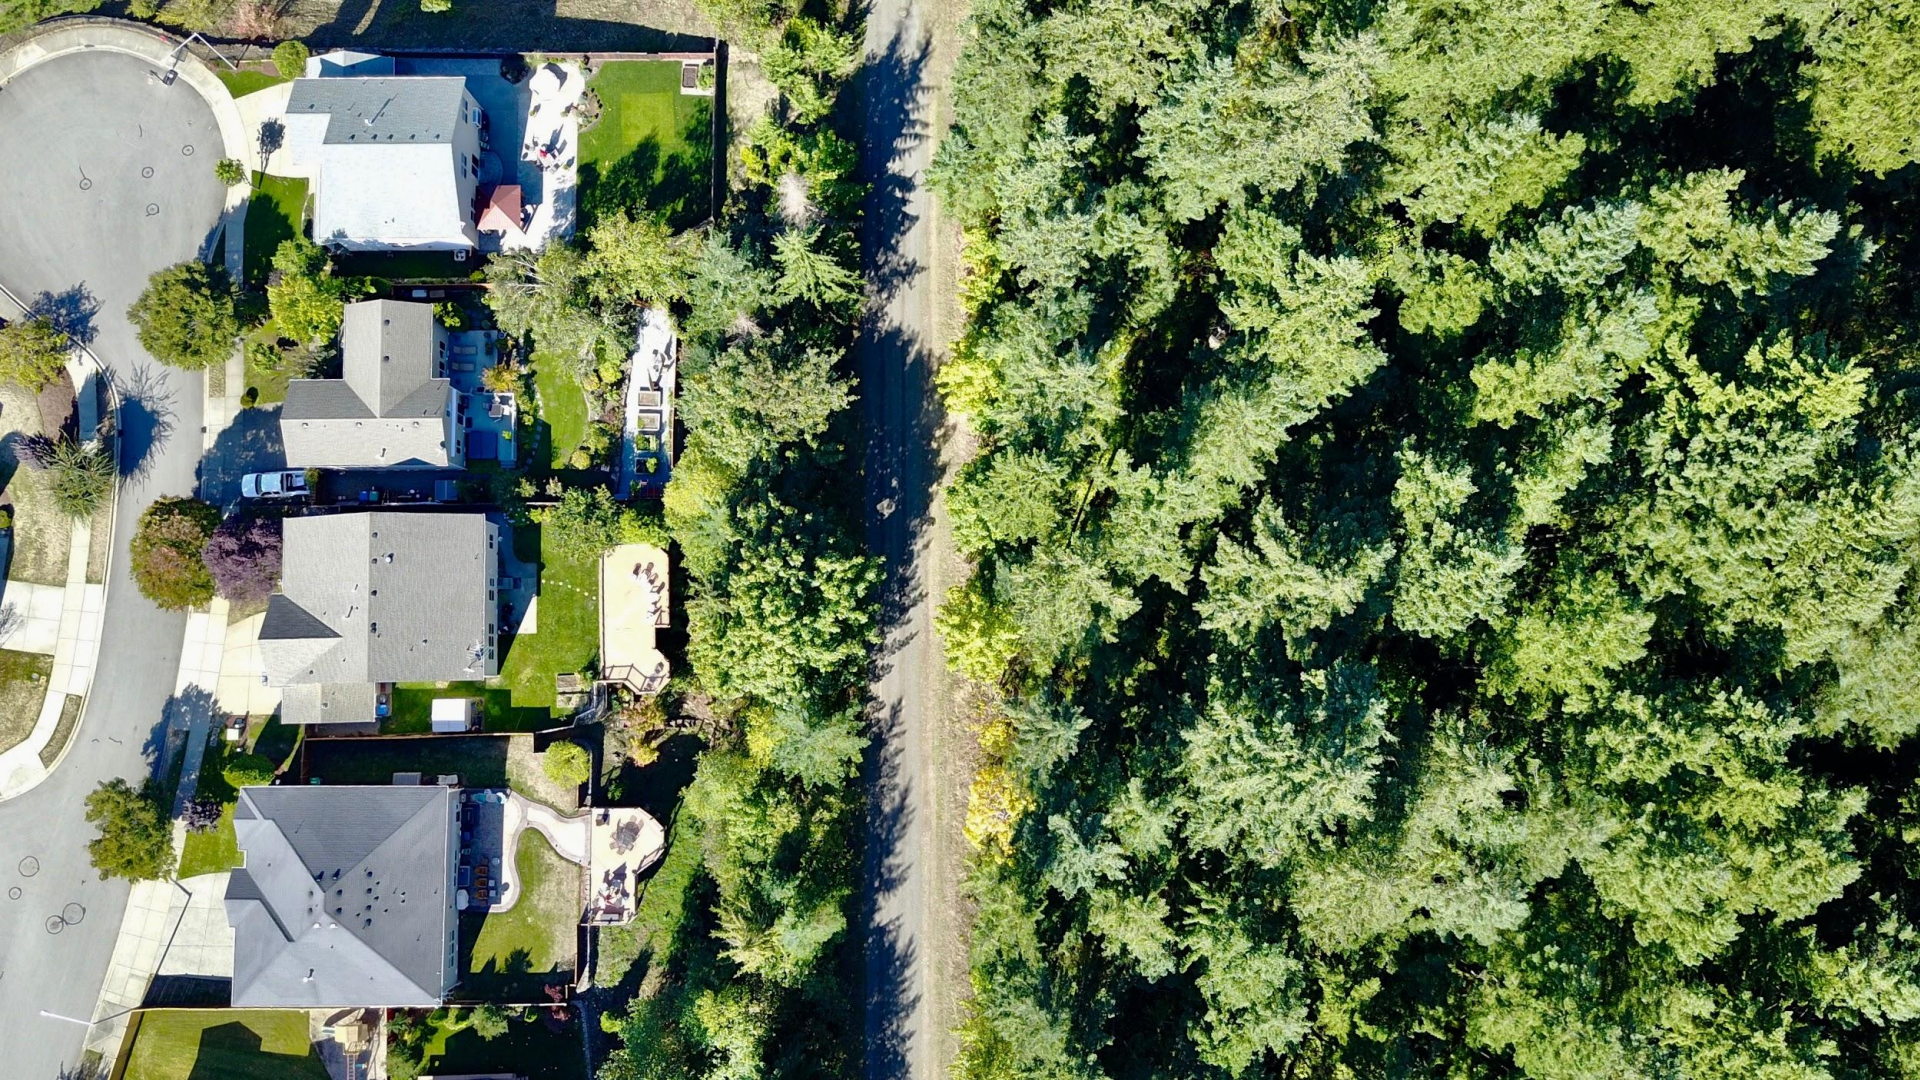
Proposed Buffer for Environmental Mitigation

Recommendation minimum of 50 ft.

Reasons for buffer zones:

- Protects tree development
- Maintain privacy
- Promotes ecology
- Provide safety
- Mitigate air and sound pollution.

Minimum Recommended Vegetation Buffer
Approximately 50 Feet

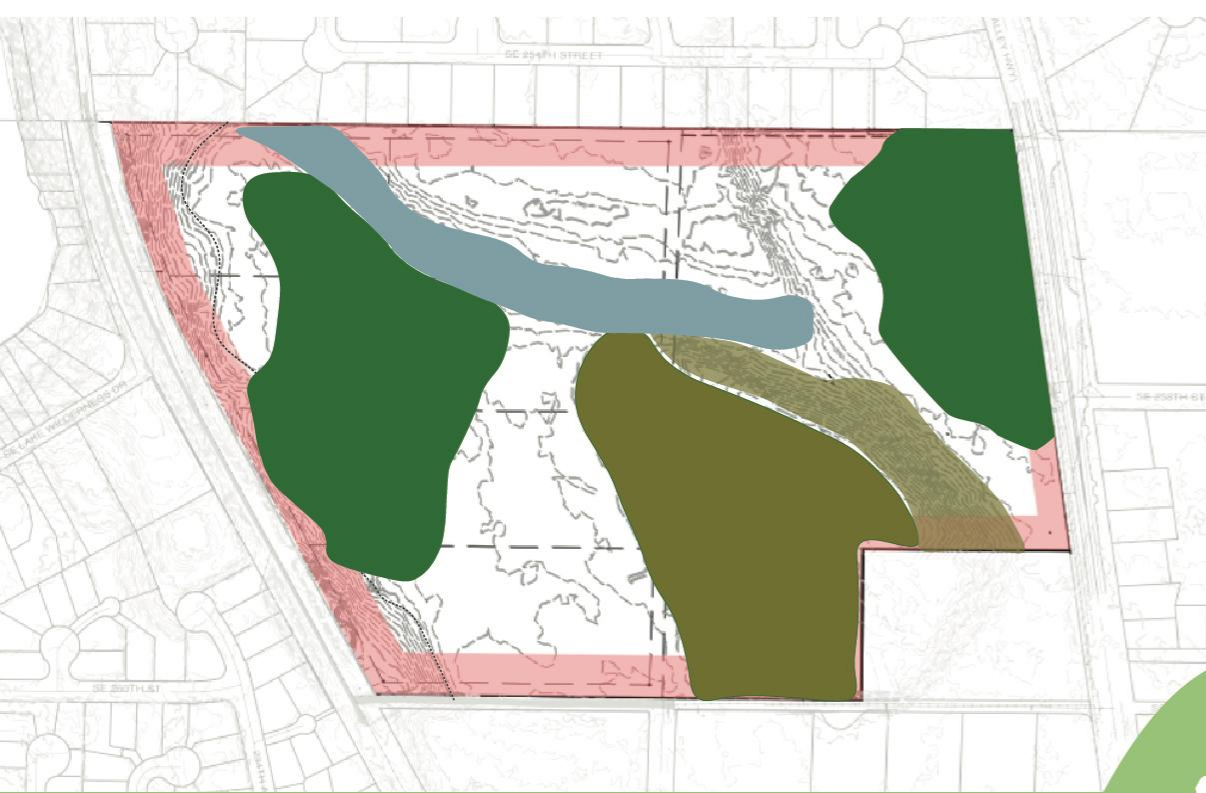
Tree Cluster Map

Western Red Cedar

Big-Leaf Maple

Douglas-Fir

Big- Leaf Maple

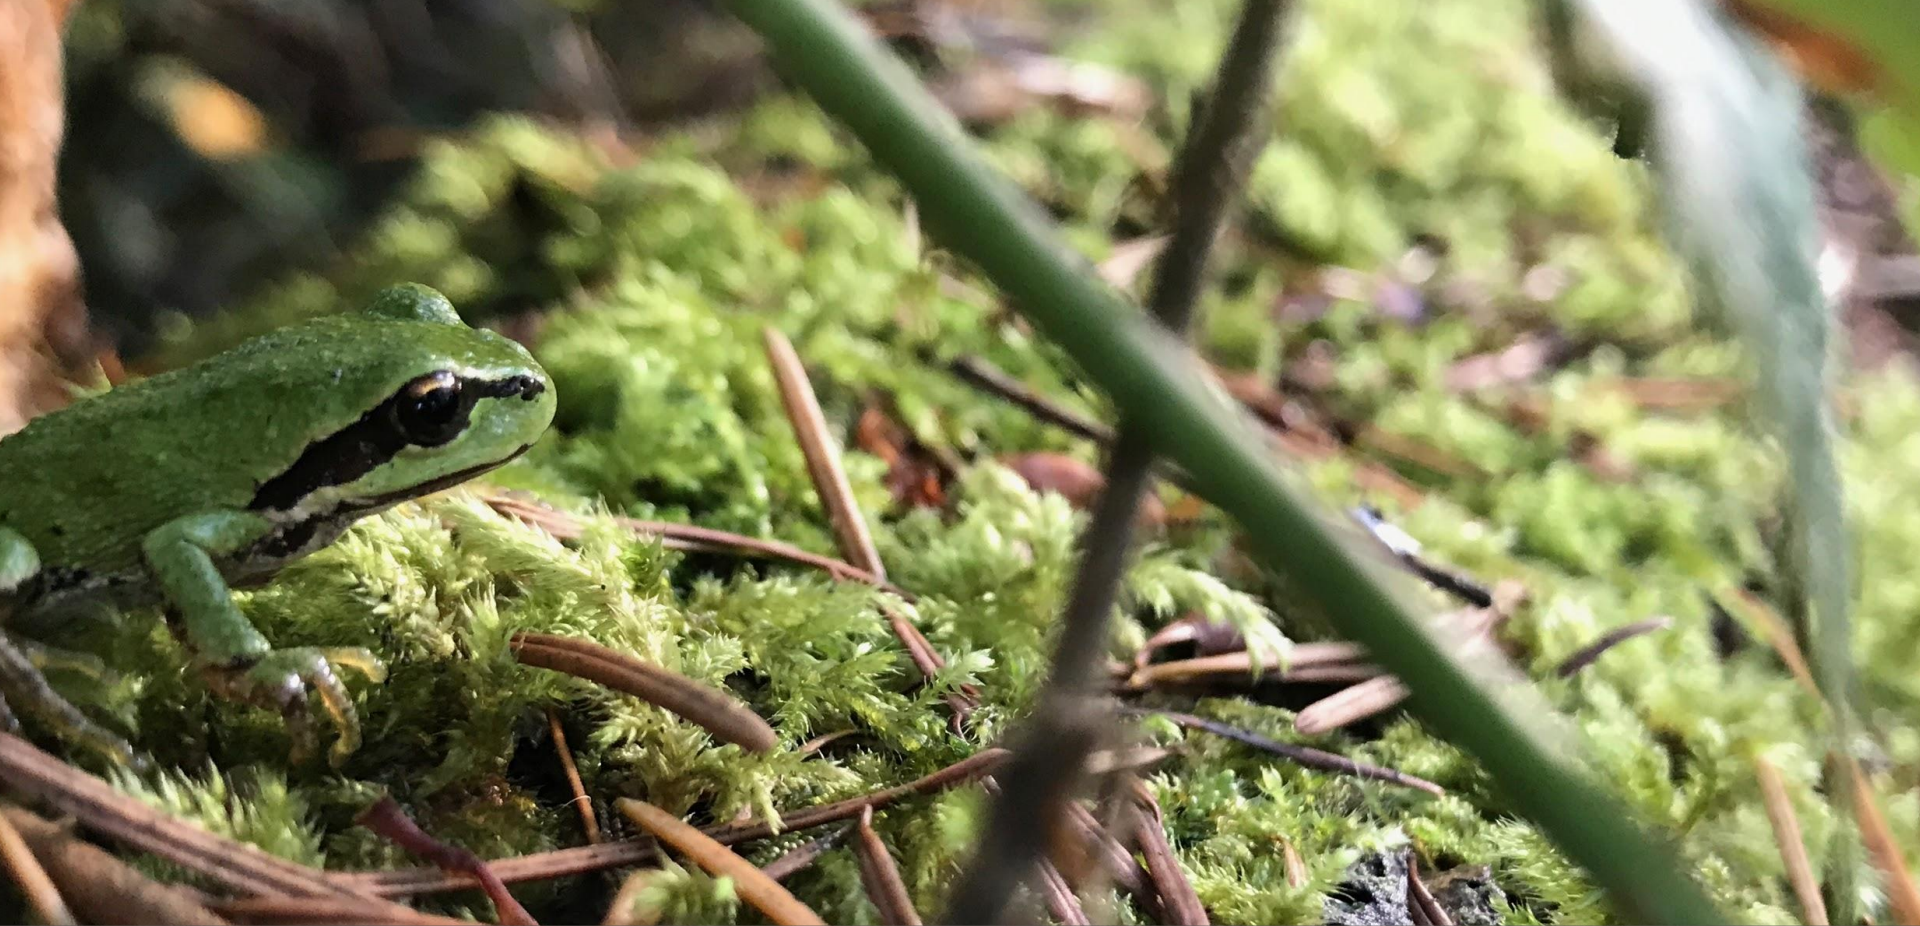
Pacific tree frog found on Legacy Site

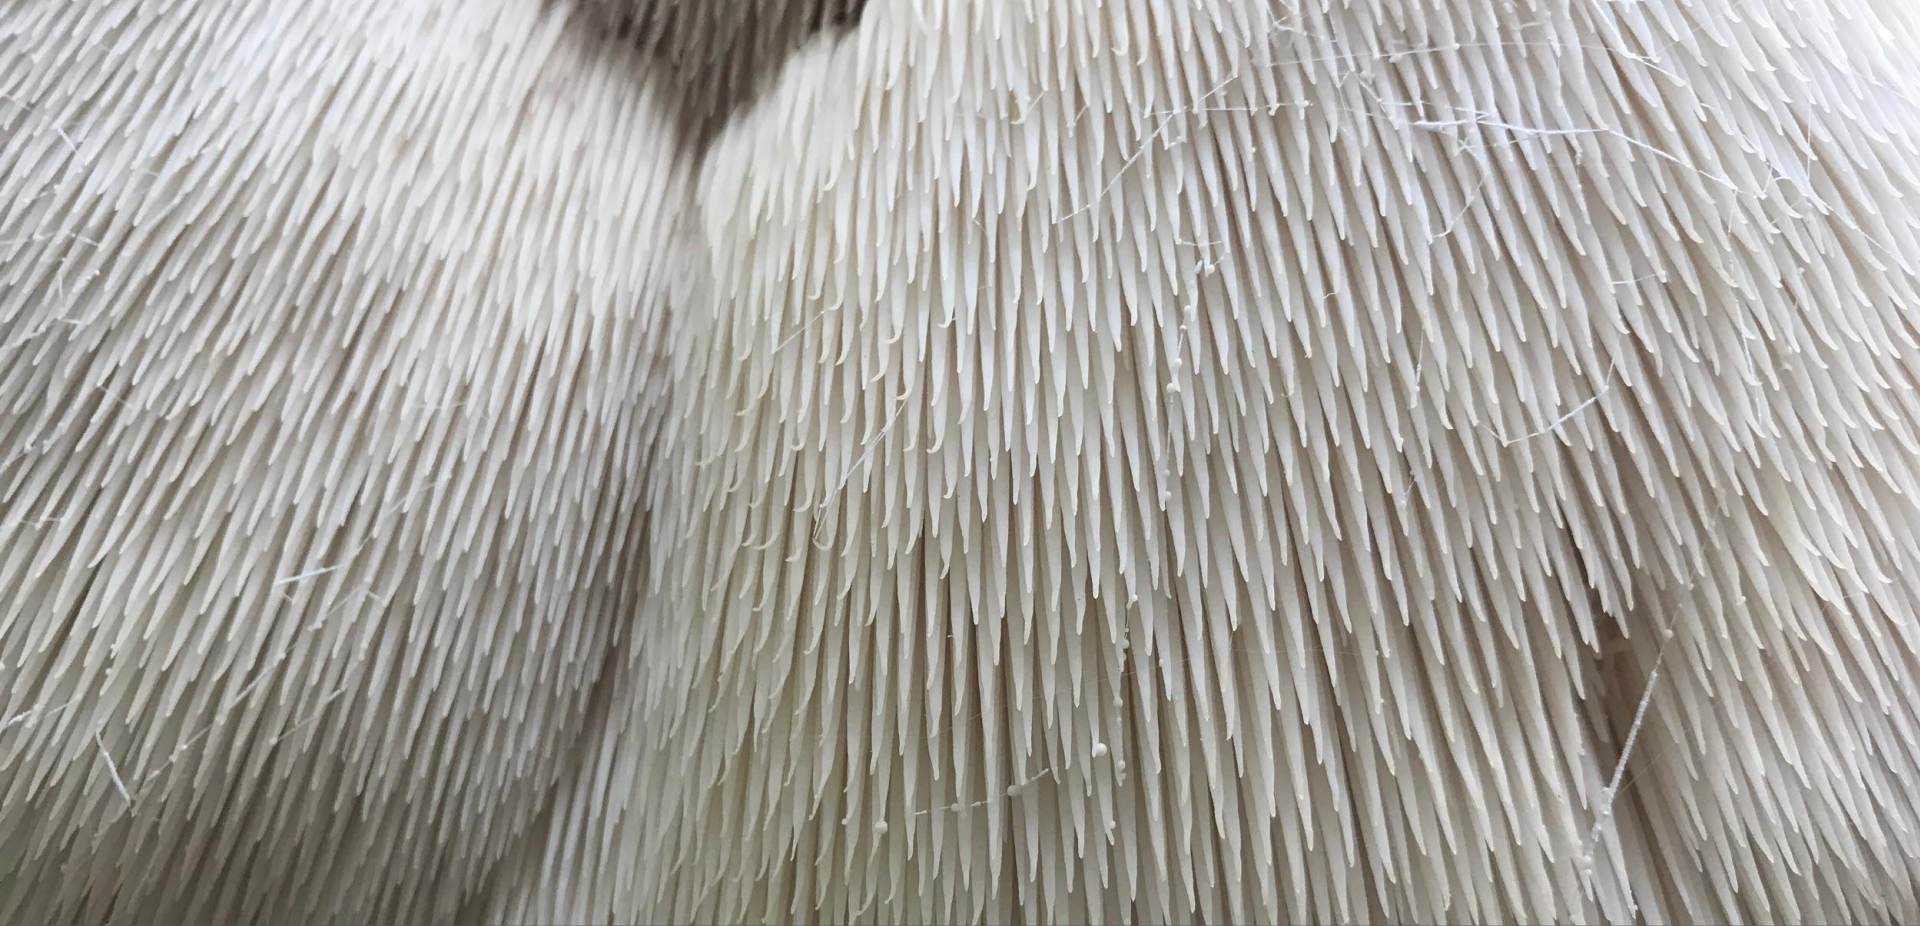
Lion's Mane Mushroom (*Hericium americanum*) on Legacy Site
